Brad Leland Professional Real Estate Inspection Services

PROPERTY INSPECTION REPORT

Report #: New Home Sample

By: Brad Leland, #5229 07/08/2011
(Name and License Number of Inspector) (Date)

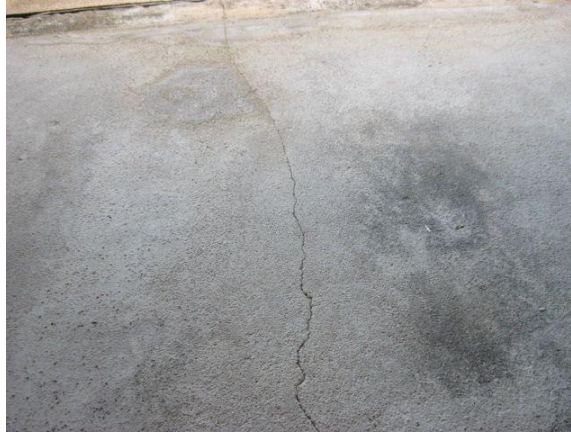
Performance Opinion: There were cracks in the finished concrete surface of the garage and some areas of the foundation face. These cracks should be monitored for any further activity.

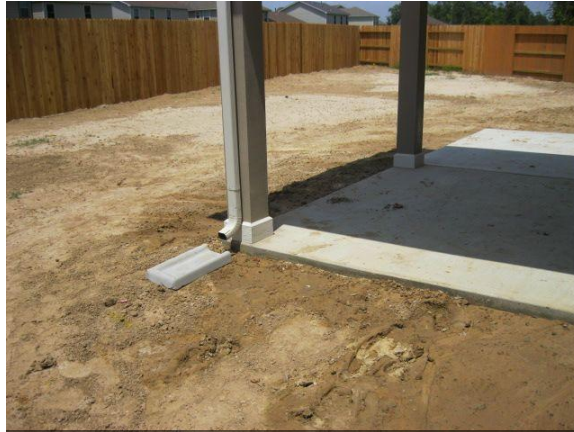
The landscaping was not complete in the backyard at the time of the inspection.

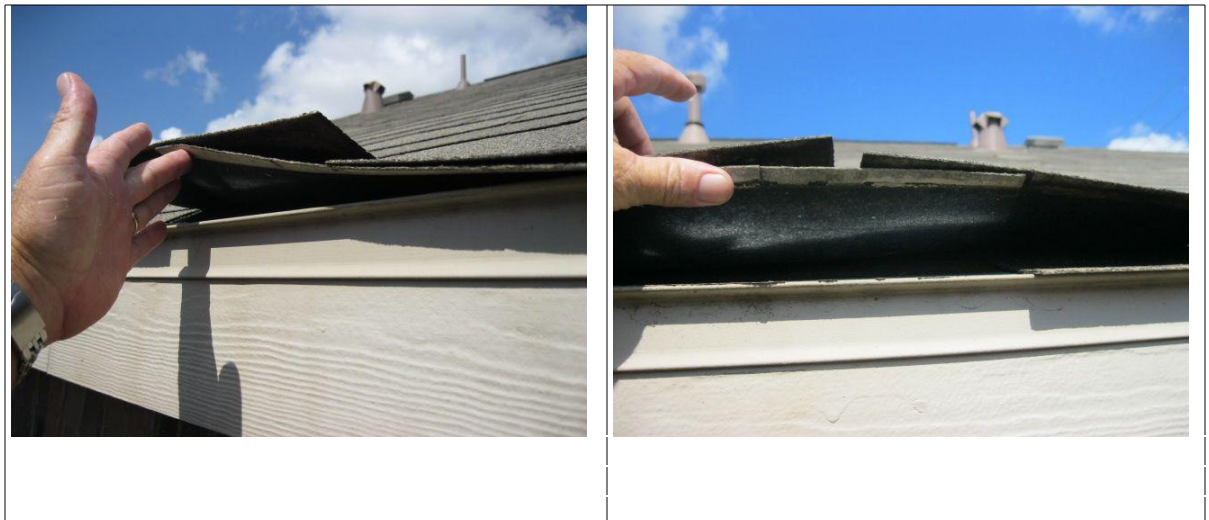
The shingles on the perimeter edge of the roof are not properly secured and can be lifted easily. These shingles should be properly secured so that they are not lifted or damaged during heavy winds.

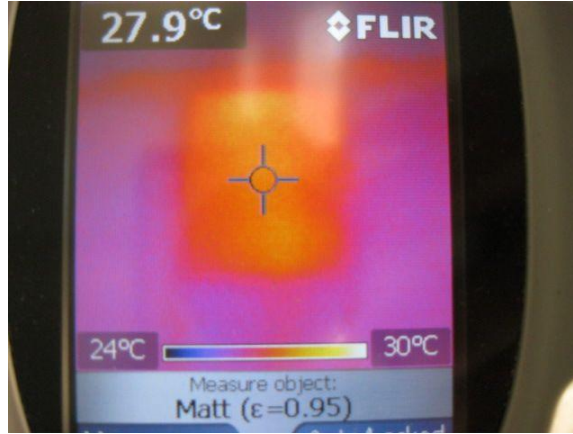
There may be insulation missing on the west wall of the dining room as a hot spot was picked up by the thermal imaging equipment. It is recommended that the builder be consulted regarding this condition.

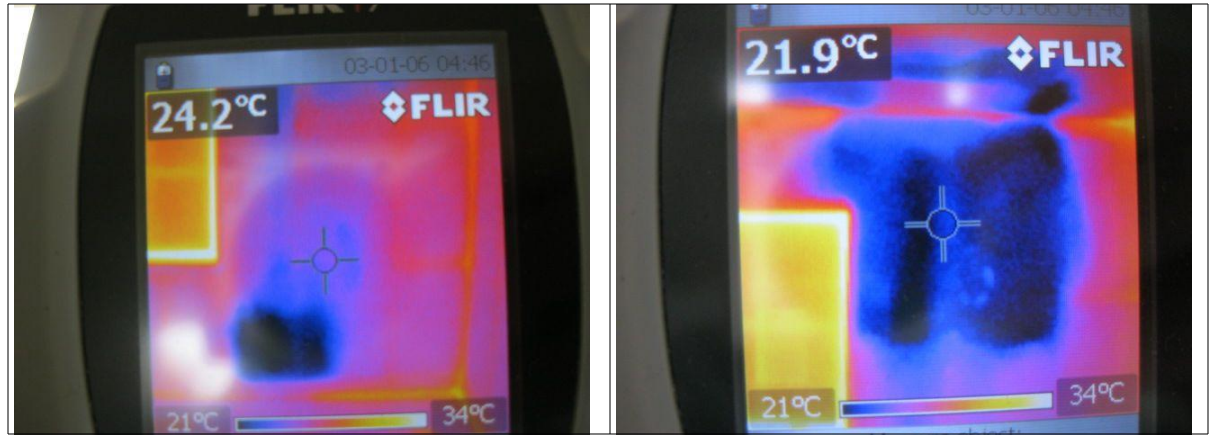
There were higher than normal moisture readings taken at the rear wall and ceiling of the game room. The thermal imaging equipment confirmed the moisture issue to the right of the rear game room windows and the ceiling above this area. Hidden damage is a possibility. All damaged material should be repaired and replaced. A separate mold inspection would be necessary to determine if this condition has caused mold growth inside of the wall in these areas.

There are higher than normal moisture readings taken at the ceiling of the game room near the rear wall over the right side of the windows (photo in wall sec). The reason for this condition is not known. It is recommended that the builder be consulted regarding this condition.

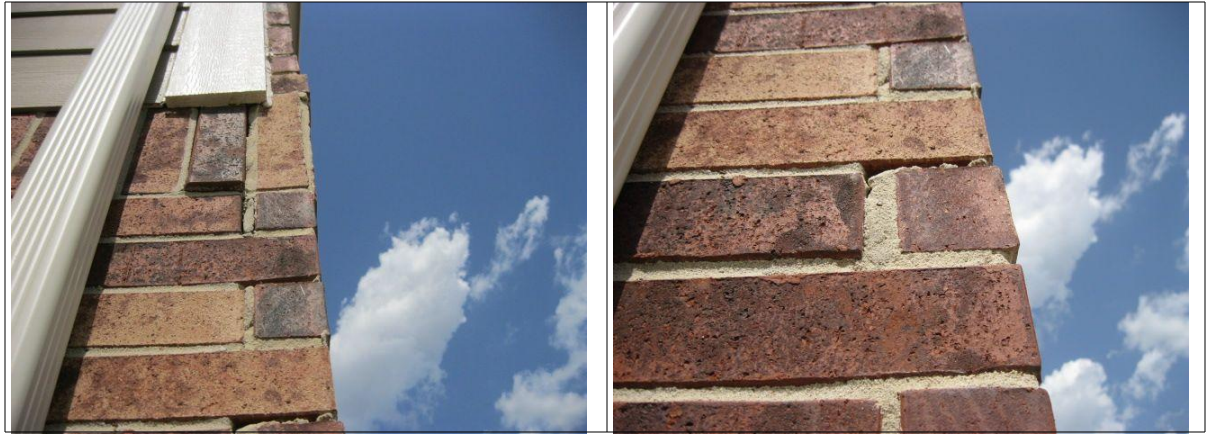
There are voids in the brick mortar at the top of the front southwest corner of the garage.

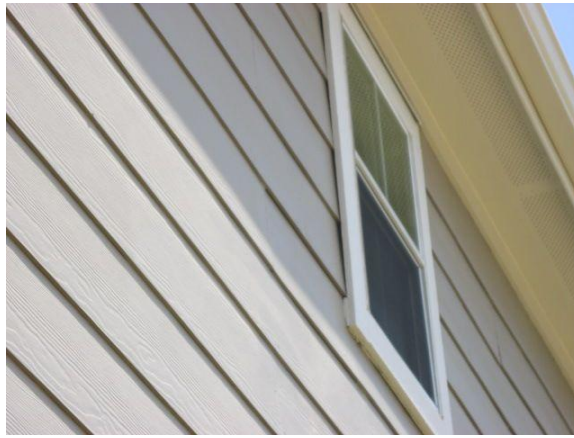
It is recommended that all exterior trim be sealed where it meets the siding, in order to prevent possible water penetration.

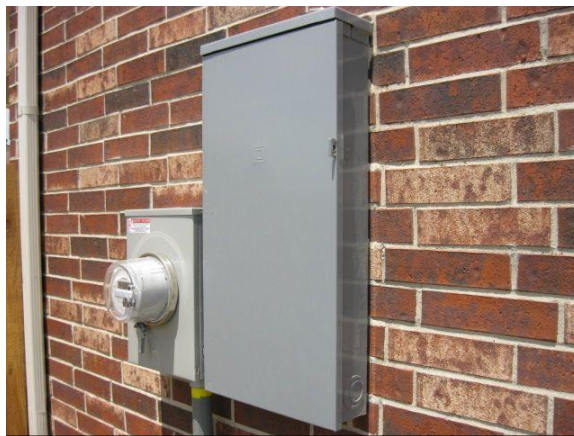
It is necessary to seal around the electric breaker box and the electric meter box enter the home to prevent possible water penetration to the structure.

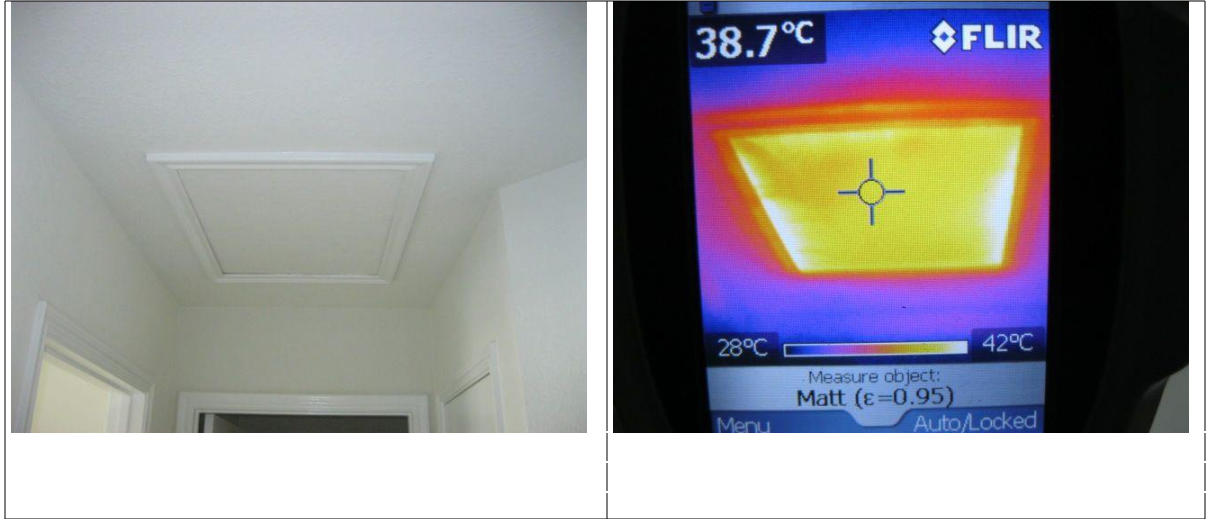
The attic access scuttle panel in the second floor hallway is not insulated. This panel should be insulated to prevent radiant heat from transferring from the attic to the living quarters.

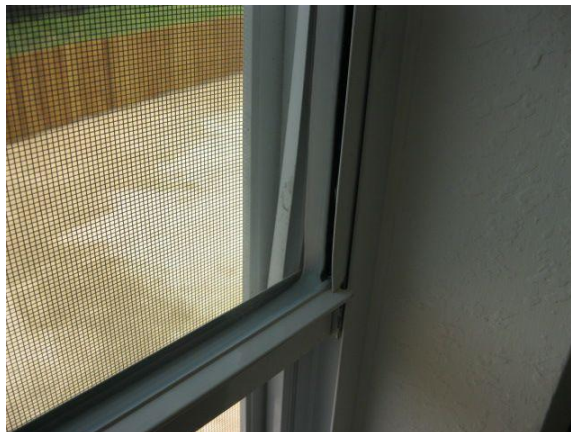
The exterior weather stripping is loose at the left window in the upstairs game room.

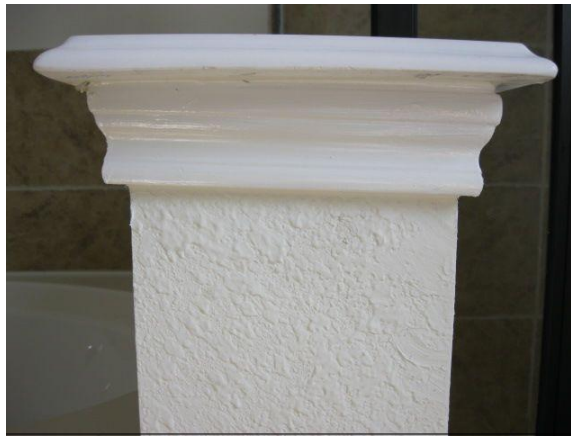
The trim under the cultured marble cap on the master bathroom shower half wall is notably not level.

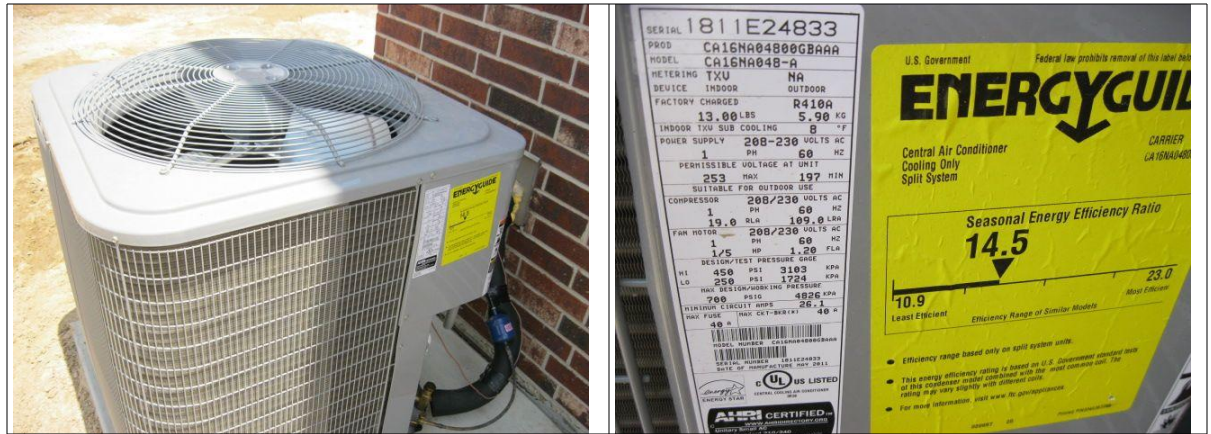
Exterior Compressor: 4 tons - 14.5 SEER

Differential Air Temperature Drop During Operation:

Air Going Into System: 78 f Returned Air: 64 f

The system appears to be performing properly.

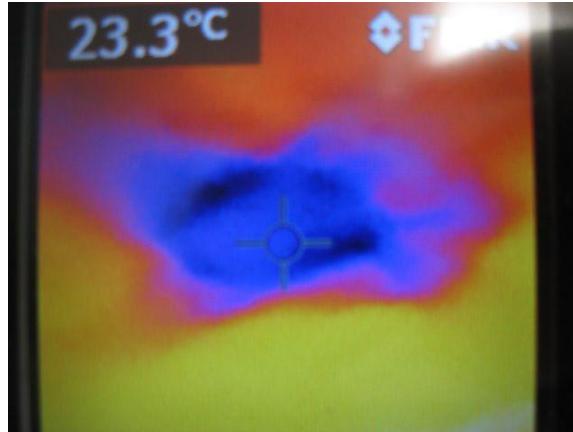
It is possible that the HVAC vent duct in the dining area has been covered with sheetrock as a cold area was observed with the thermal imaging equipment.

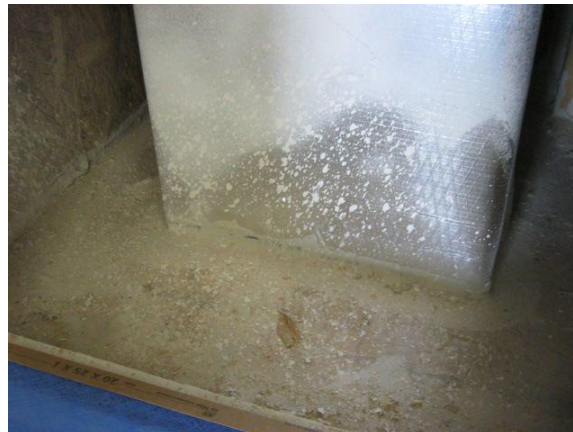
The return air chase should be cleaned out before occupancy.

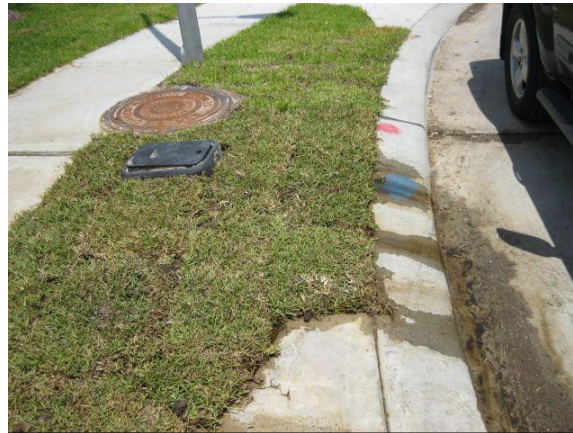
There is a leak at the water meter near the street.

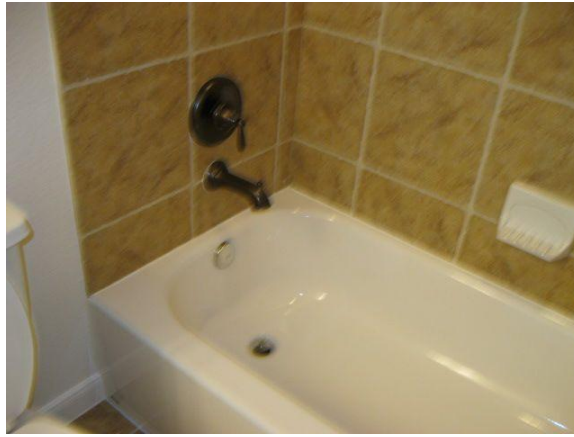
It is necessary that there be inspection ports provided for the upstairs hall bathtub/shower unit and the master bathtub unit so that it is possible to check for leaks, as well as for service to be performed on the plumbing if needed.

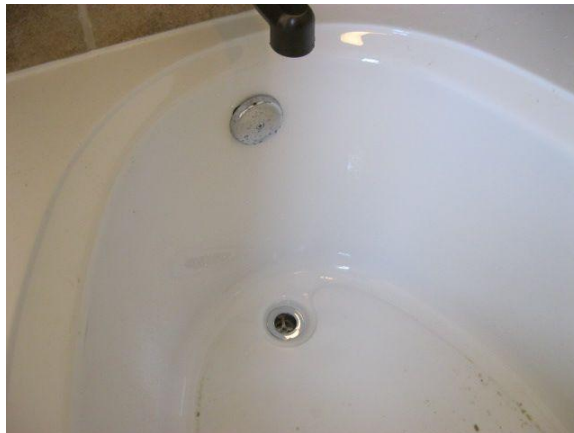
The drain stop is missing at the master bathtub.

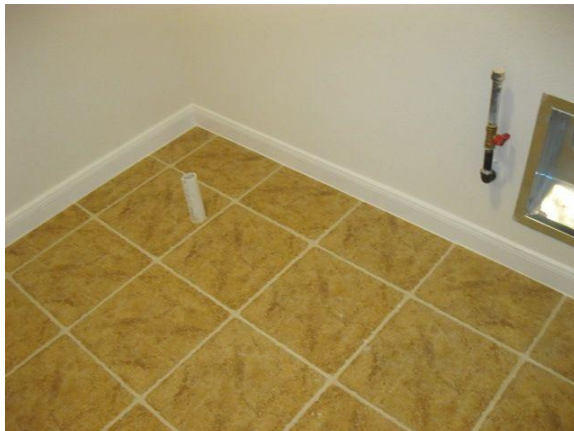
It is recommended that the washing machine located on the second floor have a safety pan installed to prevent water penetration to the ceiling and walls below in case of a leak or malfunction with the equipment.

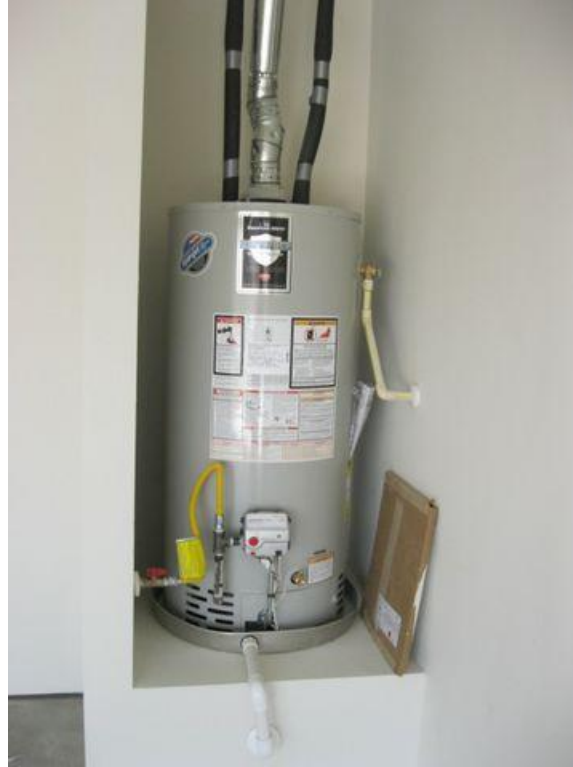
The water heater is performing properly.

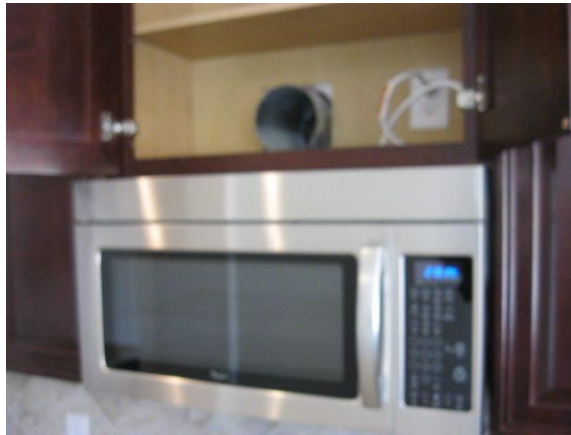
C. Range Exhaust Vent - Comments:
The installation of the ductwork in the cabinet above is not complete.
