# Property Inspection Report

## PROPERTY INSPECTION REPORT

**Report #:** BL20110113-01

**Concerning:** 1313 Your Street, TX -  
(Address of Inspected Property)

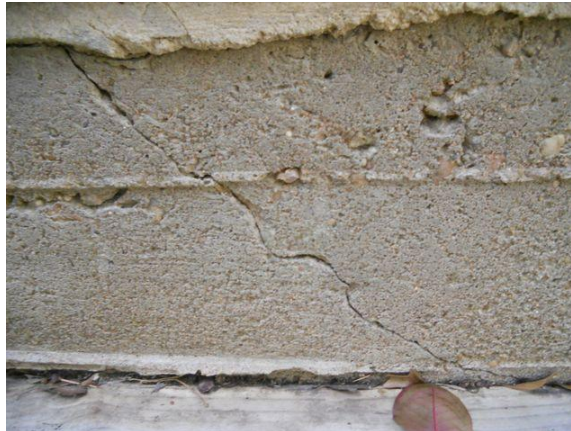
There are signs of more than normal past movement in the structure such as cracks in the exterior bricks, cracks in the interior sheet rock, a separation between the exterior bricks and the right side overhead garage door, there was a large crack in the foundation face on the northeast side of the home, there was a small crack in the foundation face at the back of the home, cracks in the concrete surface of the garage, when the downstairs was measured the northeast side was approximately 1.5 to 2 inches low and the upstairs when measured was approximately 2 inches low on the northeast side. As discussed, these conditions indicate that the foundation may require a permanent remedy to stabilize the structure in some areas. The best course to follow for foundation settlement is to consult a professional (structural) engineer so that a course of corrective procedures can be evaluated. This can consist of a certification that the foundation is functioning as intended at this time, or alternately, a plan may be designed for underpinning.

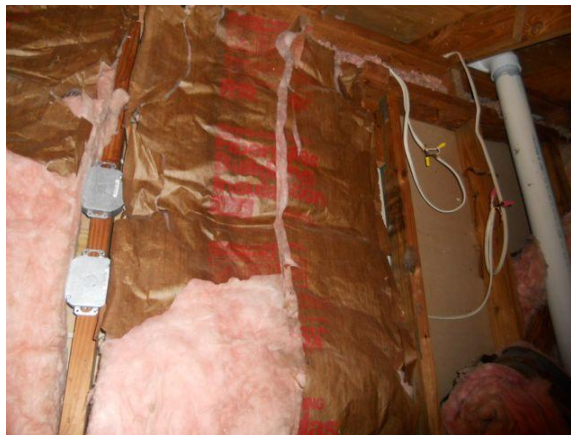
The insulation on the attic floor was thin to meet minimum current standards (r-30, 113/4") and was not complete on the interior attic wall behind the upstairs hall bathroom in the lower attic area. It is recommended that additional insulation be added for energy efficiency.

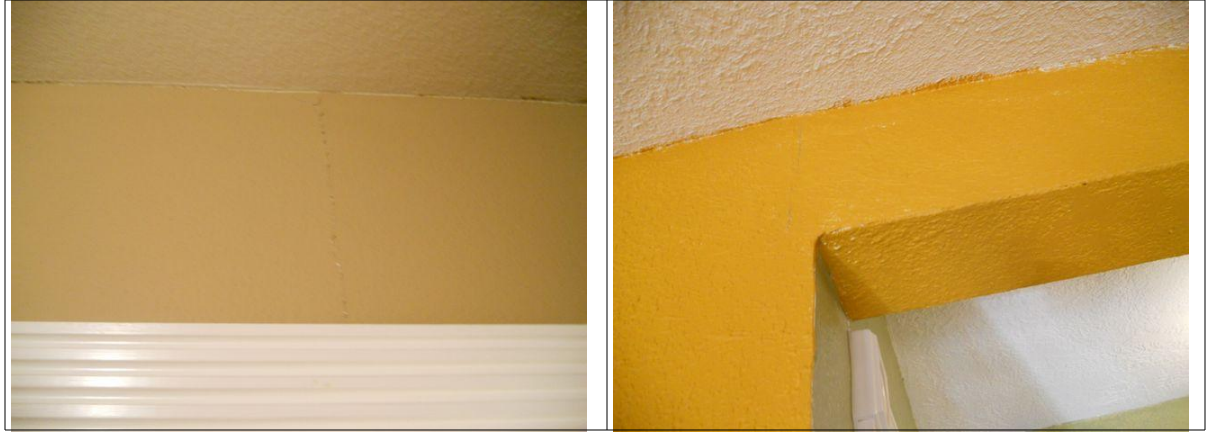
There were small cracks in the interior sheet rock above the door in the master bedroom closet, over the banister at the top of the stairs, next to the fireplace and between the top of the upstairs northeast bedroom door and the hall bathroom door. Cracks near the interior windows and doors are usually indications that there is some degree of movement occurring in the structure. An effort should be made to maintain an even moisture content in the soils surrounding the foundation.

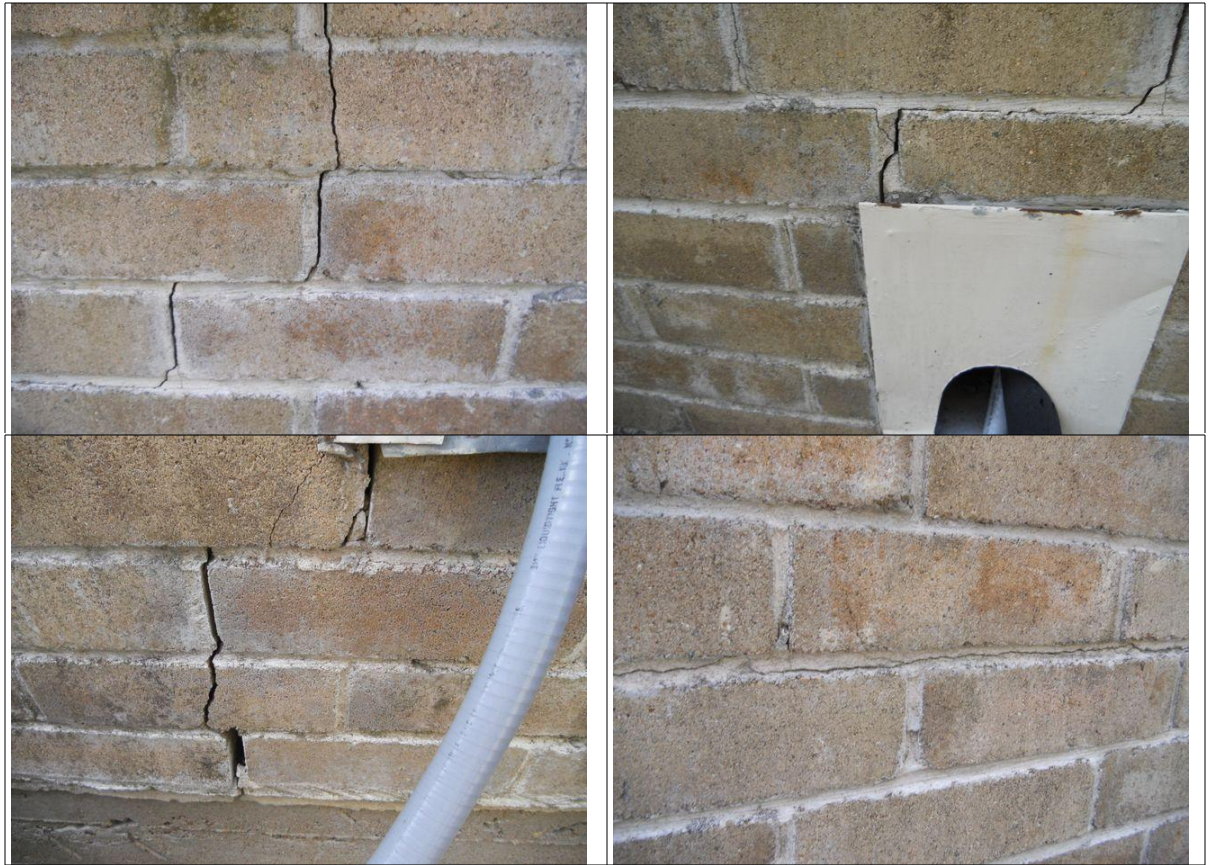
There were small cracks in the exterior brick next to the living room window, next to the chimney and next to the overhead garage doors. There were severe cracks in the exterior bricks on the northeast side of the home. Cracks near the windows and doors are usually indications that there is some degree of movement occurring in the structure. The severity of the cracks can be an indication of the amount of movement in a structure. These cracks should be filled and monitored for future movement, while also maintaining an even moisture content in the soils surrounding the foundation.

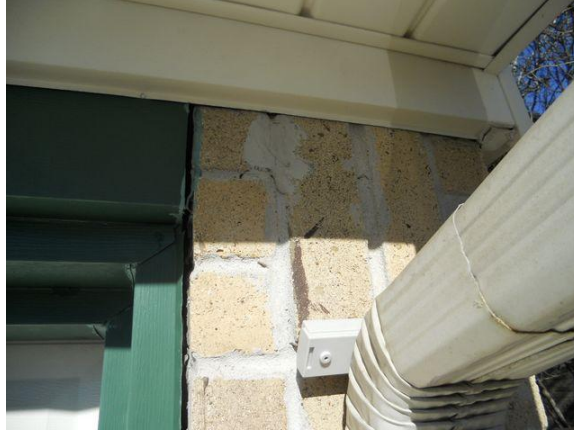
The front right/east corner of the garage appears notably low and the overhead garage door is not level or square in the opening. It was also noted that there is a separation between the bricks and the overhead garage door frame. A qualified contractor should be consulted regarding this issue.

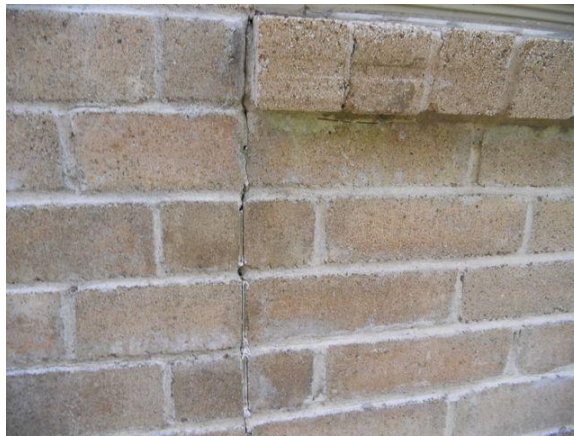
The expansion joint on the northeast exterior brick wall needs to be re-sealed in order to prevent water penetration and insect infestation.

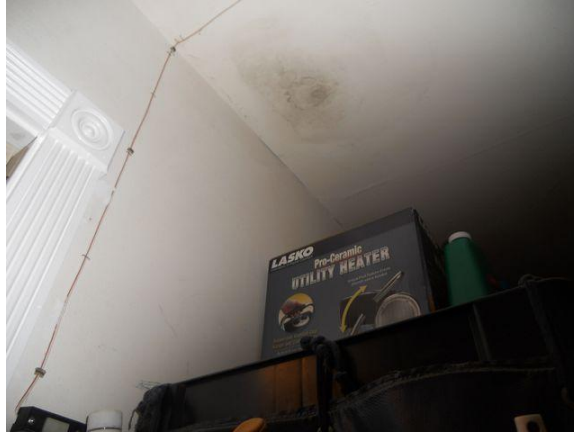
Evidence of water penetration was observed on the ceiling of the garage near the door to the home. This area was dry when tested. Leaks can cause hidden or concealed damage. This area should be monitored in the future.

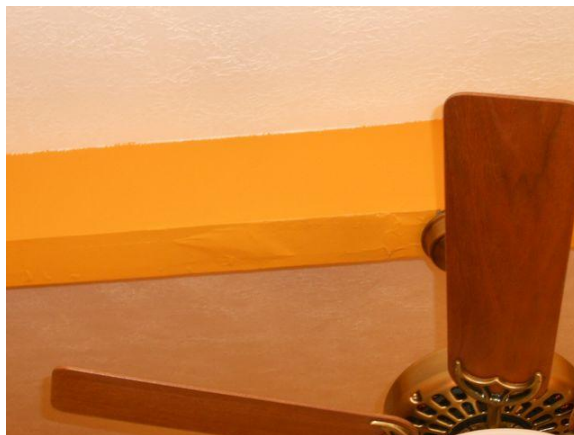
There is an area on the beam of the living room ceiling where the paint is blistered. The reason for this condition is not known. This is sometimes an indication of moisture penetration.

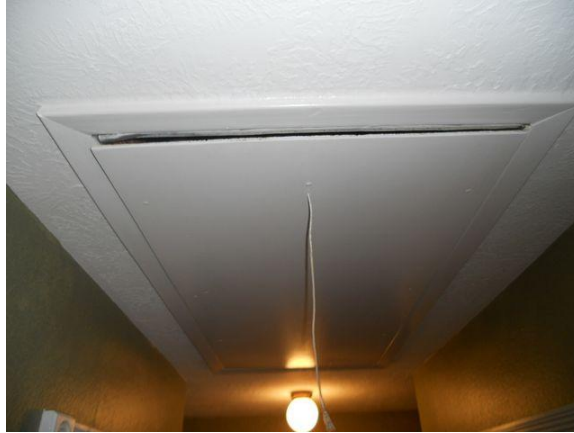
The attic access door in the upstairs hallway does not seal tight when closed. The attic door should seal tightly when closed to prevent radiant heat from transferring from the attic to the living quarters, as well as to keep cool air from escaping from the living quarters into the attic area.

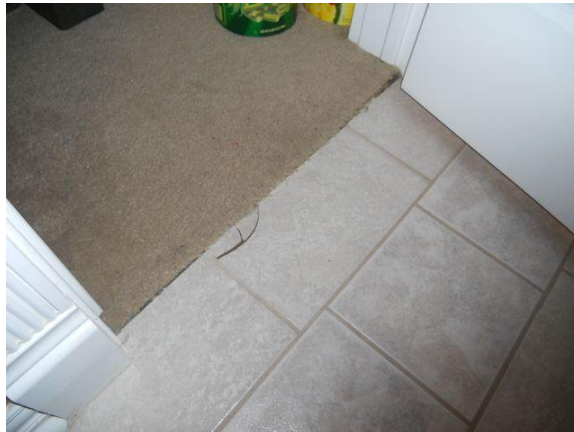
There are 2 damaged floor tiles in the downstairs hallway where it meets the carpet in front of the downstairs under stairs closet off of the kitchen.

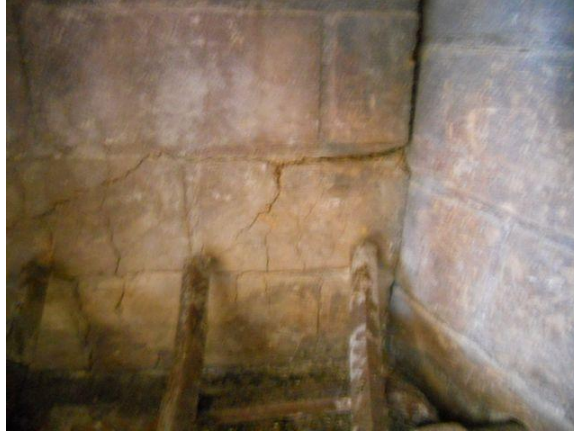
There were gaps/cracks in the firebox area/firestone/heatshield. Cracks in the fire brick or gaps in the mortar can result in house fires. Most small openings can be sealed using a temperature rated fireplace caulk. I recommend consulting a chimney sweep service company so a corrective course of action can be evaluated.

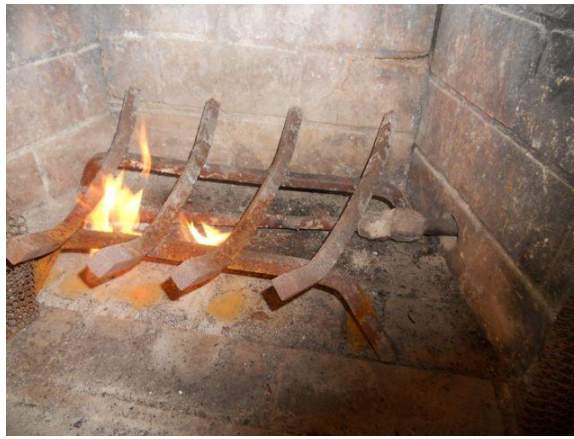
The gas igniter tube is not dispersing the flame evenly.

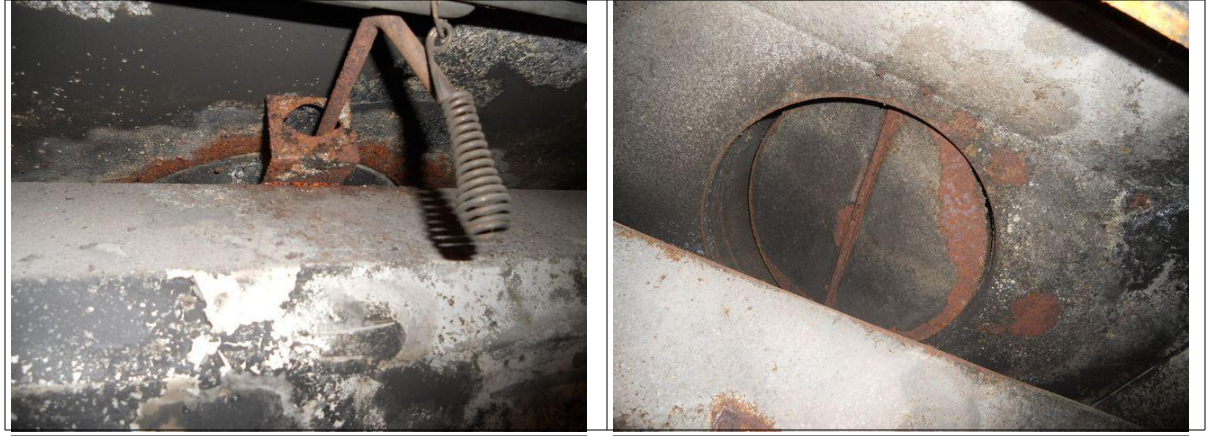
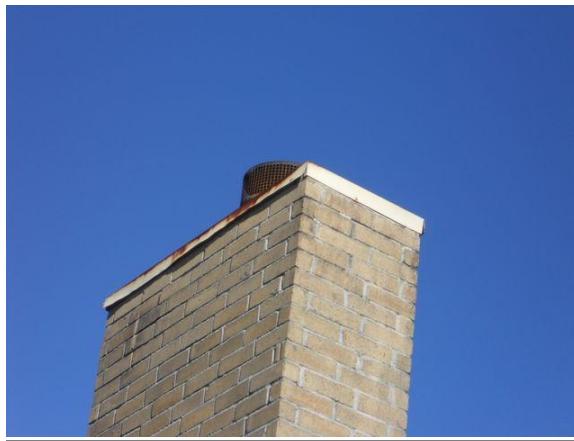
The damper assembly would not operate easily due to corrosion.

There was corrosion in the firebox, on the damper assembly, the igniter tube, chimney cap and chimney flashing. This/these conditions are an indication of possible moisture penetration.

It is recommended that a chimney sweep be consulted regarding these conditions as well as check the entire fireplace/chimney system for any other possible defects.

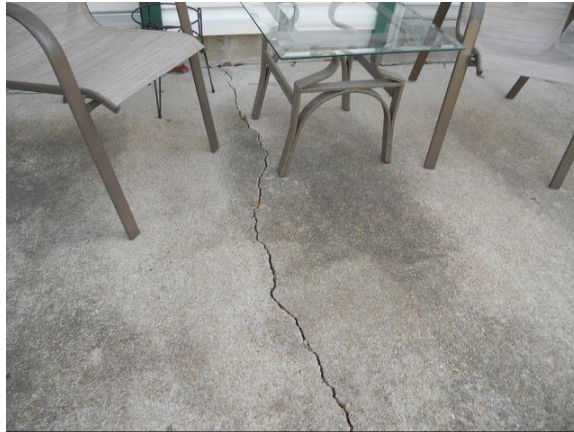
It was observed that the concrete patio has cracked in the back of the home.

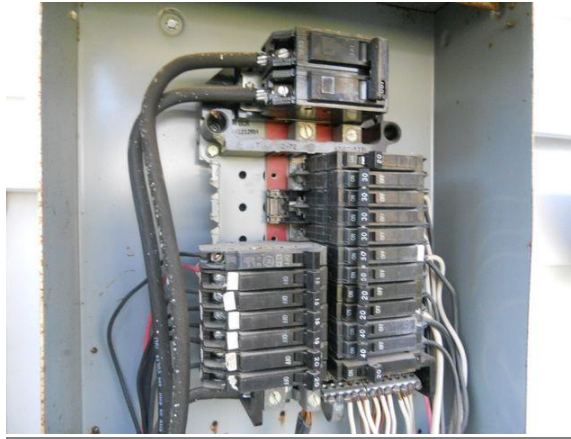
An inhibitor paste does not appear to be applied to the main aluminum wires. The surface of aluminum oxidizes when it is exposed to air resulting in a poor connection.

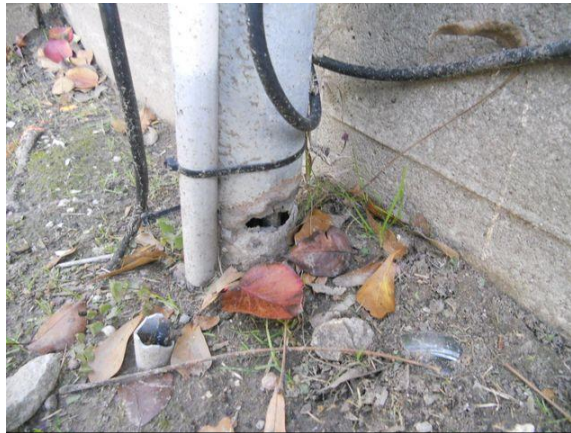
The conduit for the main supply wires is corroded where it goes into the ground which will allow some rain water to enter the conduit.

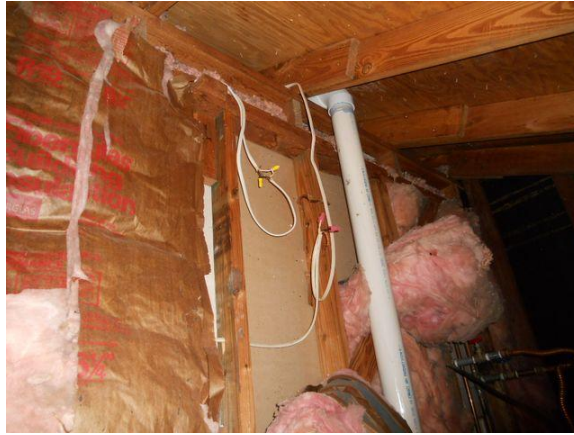
Wires were improperly spliced or terminated in the lower attic area. Wire ends or splices should be in junction boxes that are properly mounted. This condition is considered an electrocution/fire hazard and should be serviced by a licensed electrician.

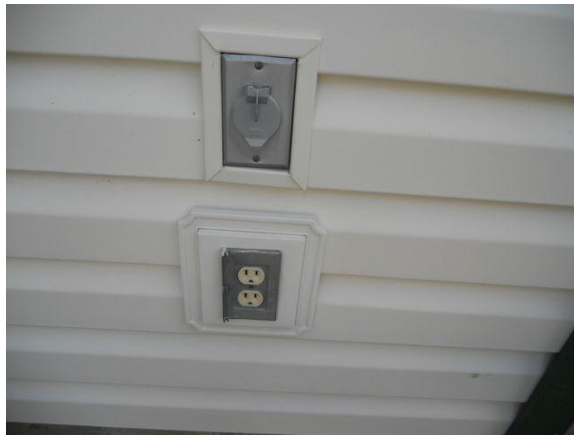
The exterior outlet at the back of the home should have a weather guard cover plate installed to protect it from water penetration and possible electric shorts.

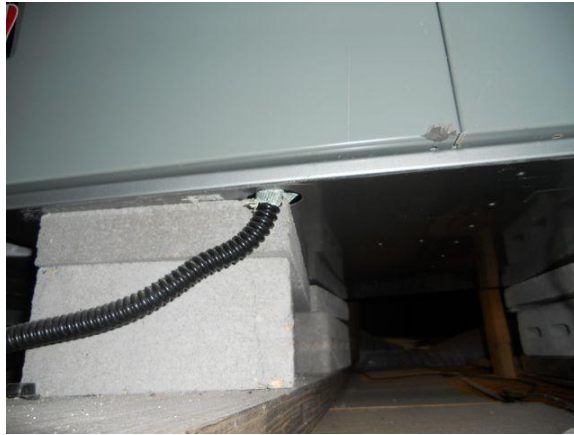
The flexible gas line enters through the furnace box. This gas line must be hard piped out of the furnace box before the flexible gas line is connected in order to prevent the flexible gas line from being cut by the sharp edges of the furnace box.

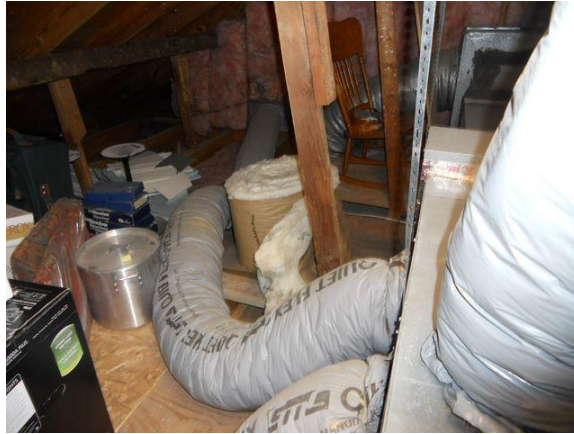
The duct work was not strapped up off of the attic floors as it should be in order to provide maximum air flow and also to prevent damage to the ducts.

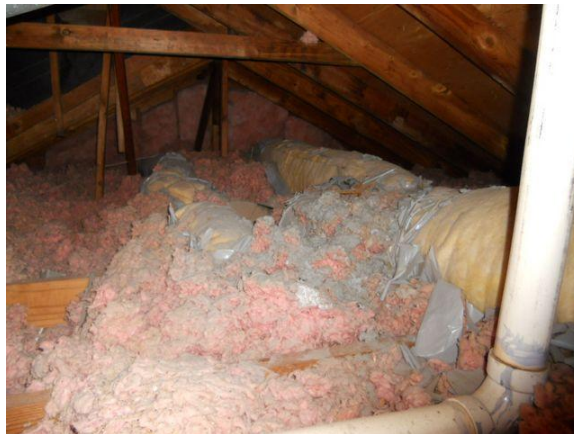
The ductwork coating is torn on the ducts in the upper attic area. It is recommended that the coating and insulation be complete for energy efficiency of the HVAC system.

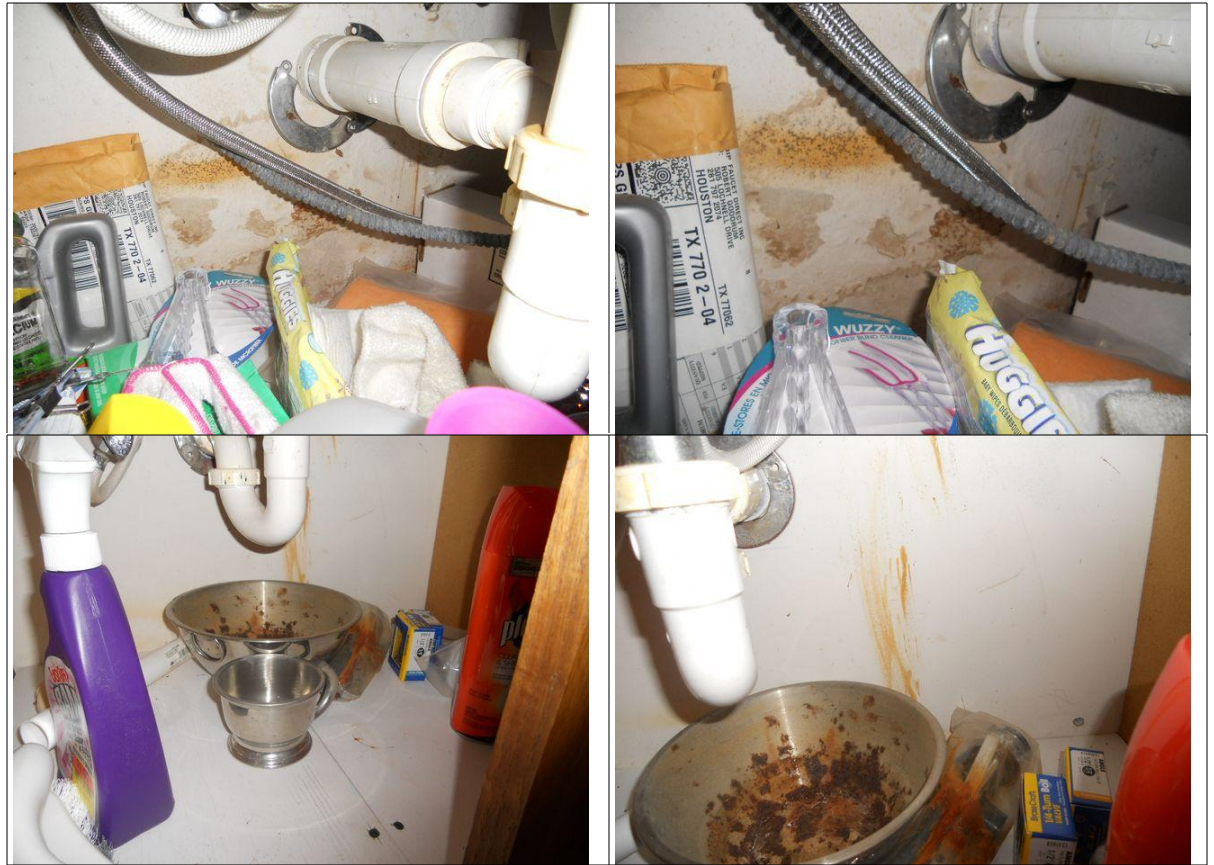
There were water stains and discoloration on the plumbing wall under the kitchen sink and the downstairs half bathroom. This/these areas were dry at the time of the inspection.

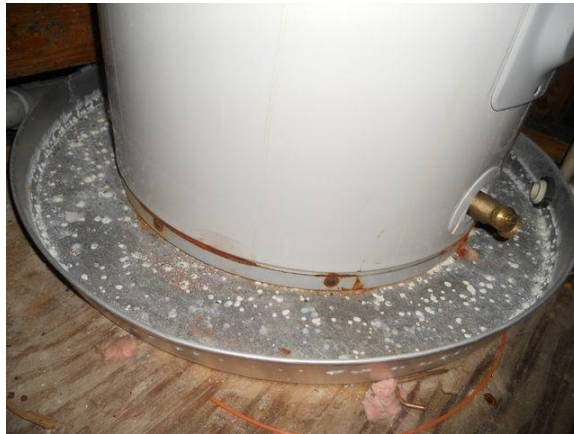
As discussed minor corrosion was observed on the water heater tank. The reason for this condition was not determined.

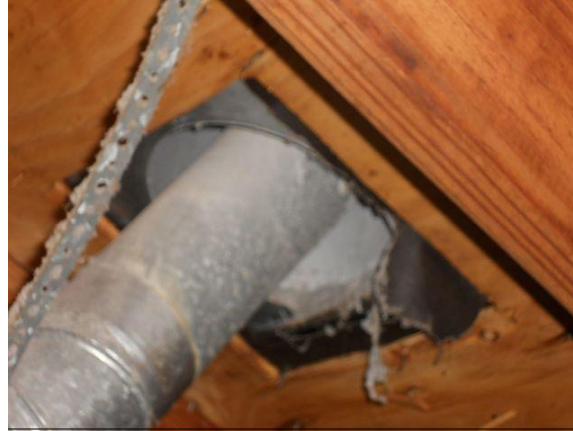
There was a build up of lint where the dryer vent goes through the roof in the upper attic which is an indication that the duct may need to be cleaned out before further use as blocked dryer vents can result in house fires.

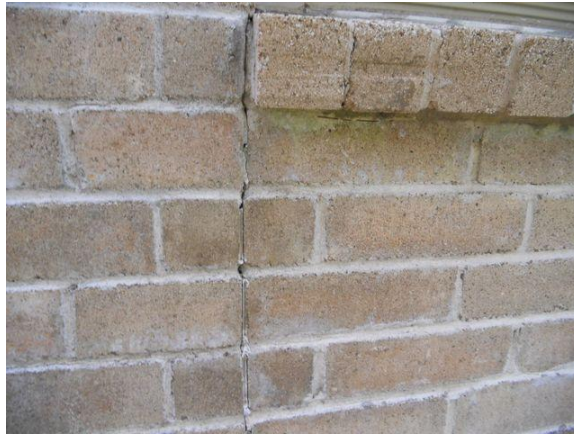
The expansion joint on the northeast exterior brick wall needs to be re-sealed in order to prevent water penetration and insect infestation.

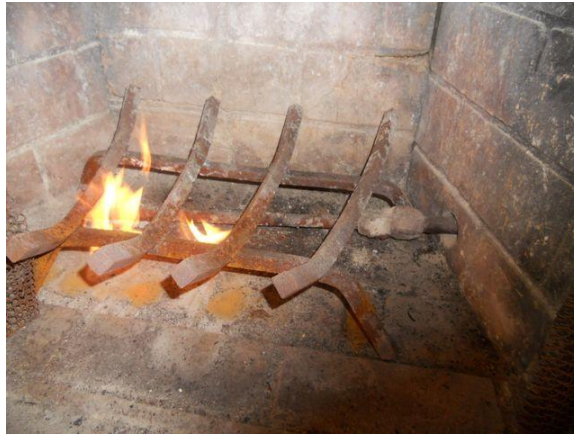
The gas igniter tube is not dispersing the flame evenly.

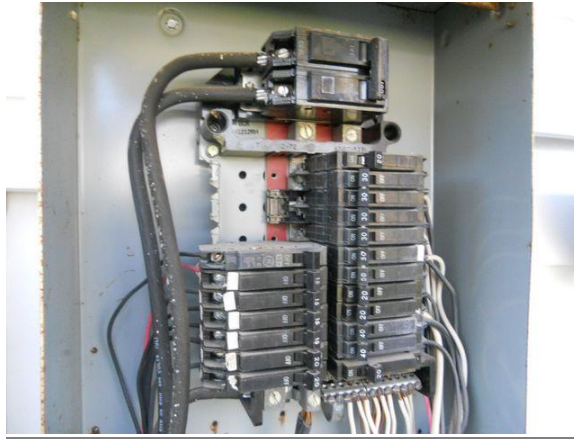
An inhibitor paste does not appear to be applied to the main aluminum wires. The surface of aluminum oxidizes when it is exposed to air resulting in a poor connection.

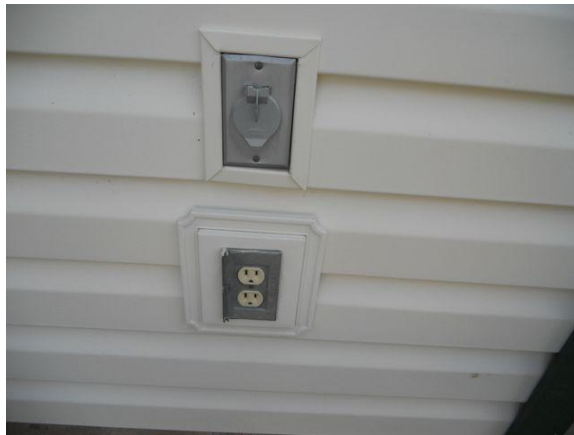
The exterior outlet at the back of the home should have a weather guard cover plate installed to protect it from water penetration and possible electric shorts.

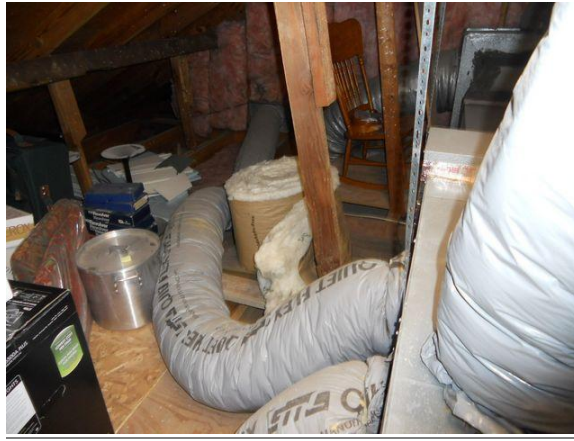
The duct work was not strapped up off of the attic floors as it should be in order to provide maximum air flow and also to prevent damage to the ducts.
